BULLETIN #103

APRIL 25, 1989

P-36 AND P-37 KITS

P34630 WASHERS

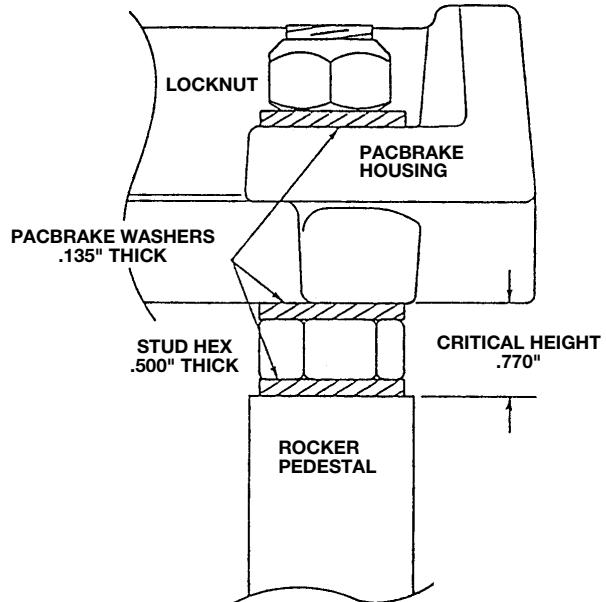
Please note that the Jacobs Mfg. Co. uses both thicker and thinner washers than ours, as well as shim packs on their earlier models. None of these are compatible with the Pacbrake kits and MUST NOT be used.

With reference to the diagram, it will be readily appreciated that should a thicker washer than .135" be used in either location between the brake housing and pedestal, then the housing will be positioned too high. If this allowed to occur, then the slave pistons may become over extended, causing the circlip to be forced from the housing. This can cause engine or engine brake damage.

Conversely, should a washer less than .135" be used, or even left out altogether, in either location, then there is a danger of the rockers contacting the underside of the brake housing, and/or our locating pin having insufficient clearance. Serious damage to the rockers, shaft or pedestal may result.

By using ALL Pacbrake P34630 washers ground to .135" thickness - 3 to each stud - there can be no chance of a thicker or thinner washer being placed in a position which could affect the correct working height of the brake housing.

It is also advisable to check the centre pedestal head bolts on each rocker shaft, even though they may not have been disturbed during installation of the engine brake. These have been found on occasion to have 2 washers under the head, and if left unchecked, will cause the housing to be high centered on the capscrew head, with obvious unsatisfactory results.
