/// service procedure

L6098

Subject: C11300 Replacement Procedure
Navistar #1893172C91

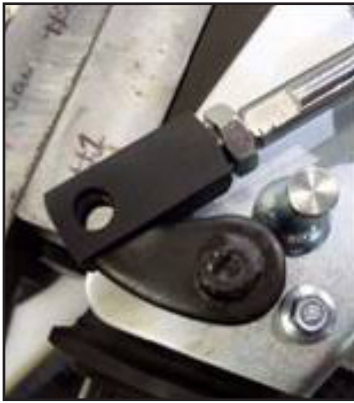
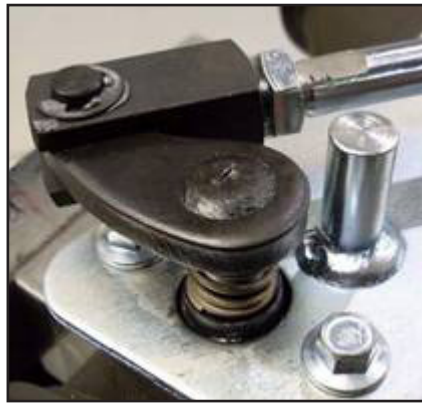
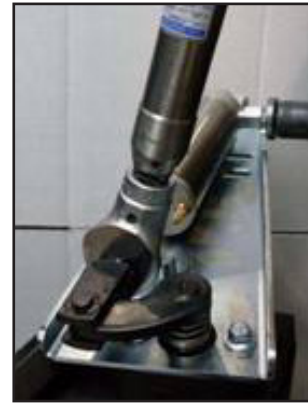
- 1 Apply shop pressure to the 12mm port (minimum 100 PSI and maximum 150 PSI) extend the cylinder.
- 2 Install one of the new e-clips provided on the new clevis pin.
- 3 Apply anti-seize to the clevis pin and install through the clevis and through the butterfly arm, then install the remaining e-clip on the lower side of the clevis pin.

- 4 Using a 3/8" open end wrench on the cylinder rod, rotate the rod to extend the travel closing the butterfly. Once the butterfly becomes close to fully closed, move the clevis up and down on the butterfly arm while rotating the cylinder rod. Once the butterfly contacts the ID of the bore the clevis will no longer move freely up and down on the arm, at this point back off the adjustment slightly to achieve slight movement.
- 5 Tighten the lock nut to 25 ft-lbs (35 N•m). Re-check to ensure the adjustment is unchanged.
- 6 Install the original air inlet fitting into the assembly.
